FINAL REPORT JULY 2007

REPORT NO. 06-04F

EVALUATION TRANSPORTABILITY TESTING OF THE JOINT MODULAR INTERMODAL PLATFORM (JMIP) UNIT #4 TP-94-01, "TRANSPORTABILITY TESTING PROCEDURES"

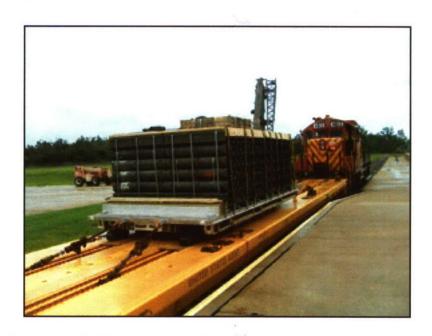
Photo 1. Rail Impact Testing of the JMIP (Prior to Testing)

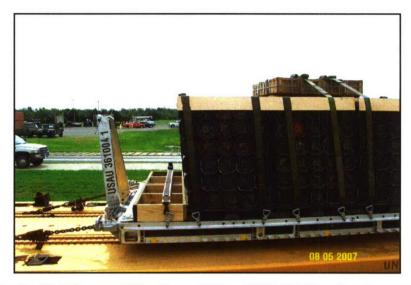
Photo 2. Rail Impact Testing of the JMIP (Following Impact #4)

- 1. Figure 5 lists the average speeds of the specimen car immediately prior to impact with the anvil. Impact #4 is the reverse impact.
- 2. The JMIP was secured directly to the railcar for testing.
- 3. Following Impact #1, the payload compacted in the direction of impact 1.25 inches.
- 4. Following Impact #3, the payload racked and the top pallet moved in the direction of impact.
- 5. Following Impact #4, the dunnage at the non-bail-bar end of the JMIP moved 0.25 inches. The end gate was no longer vertical and had moved up 0.5 inches from the JMIP deck.
- 6. Following Impact #4, the payload had moved excessively and was no longer safely and properly positioned on the pallets. The end of the payload did not have cross straps. The testing was stopped and the JMIP was unloaded. See Photo 2.

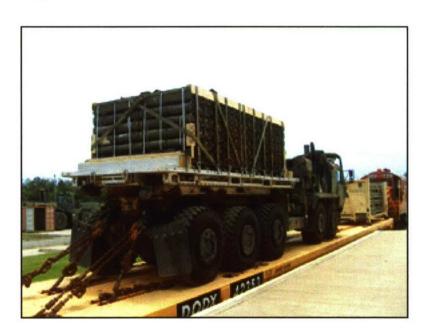
Photo 3. Rail Impact Testing of the JMIP (Prior to Testing)

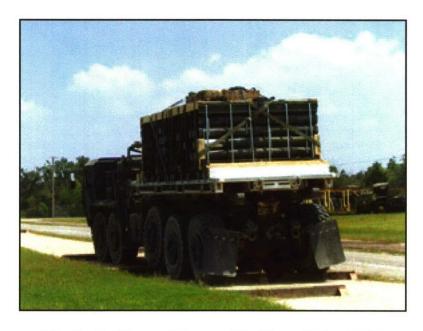
Photo 4. Hazard Course Testing of the JMIP

- 1. Figure 8 lists the average speeds of the test load through the Hazard Course.
- 2. The JMIP was transported on the PLS truck.
- 3. Inspection did not reveal any damage to the JMIP.

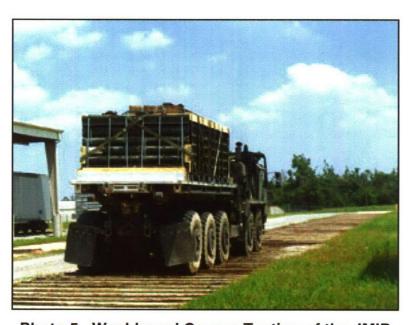
Photo 5. Washboard Course Testing of the JMIP

Remarks: Inspection following the Washboard Course revealed no damage to the JMIP.

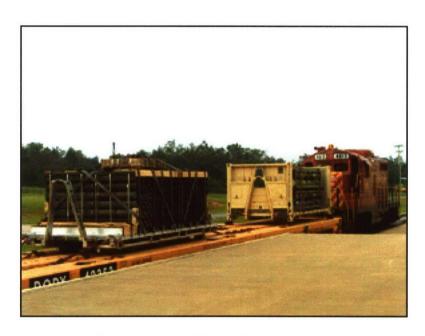
Photo 6. Rail Impact Testing of the JMIP (Prior to Testing)

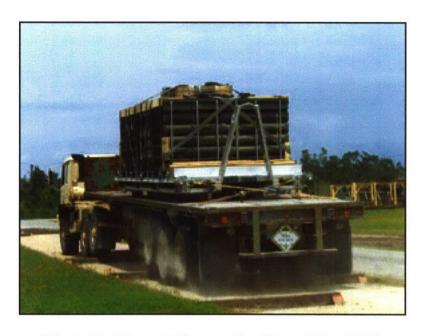
Photo 7. Hazard Course Testing of the JMIP

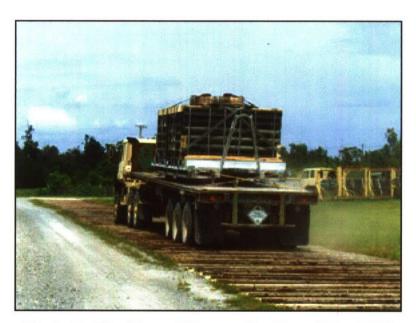
Photo 8. Washboard Course Testing of the JMIP

<u>Remarks</u>: Inspection following the Washboard Course revealed no damage to the JMIP.

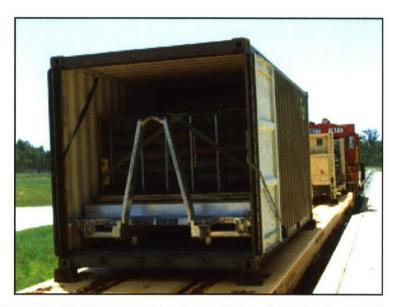
- 1. Prior to the start of testing the hard plastic end bumpers were replaced with the softer rubber end bumpers.
- 2. When loading the JMIP into the intermodal container the point load caused by the JMIP side rail deformed the wall of the container.

Photo 9. Rail Impact Testing of the JMIP (Prior to Testing)

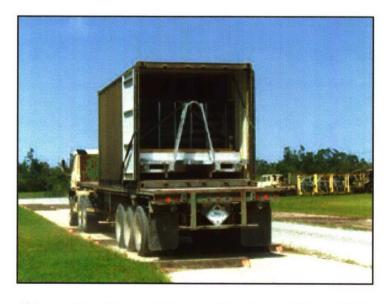
Photo 10. Hazard Course Testing of the JMIP

- 1. Figure 17 lists the average speeds of the test load through the Hazard Course.
- 2. Inspection did not reveal any damage to the JMIP.

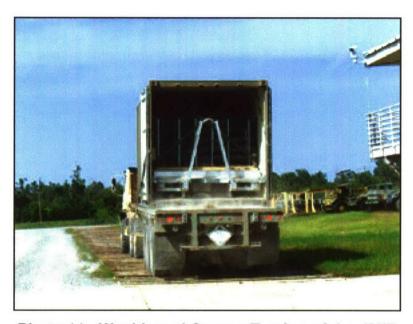
Photo 11. Washboard Course Testing of the JMIP

Remarks: Inspection following the Washboard Course revealed no damage to the JMIP.

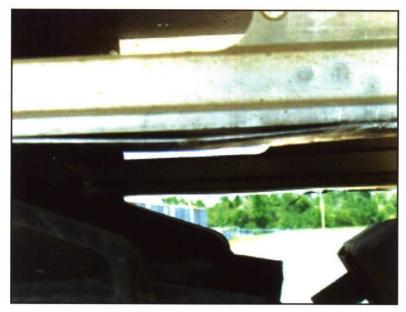
- 4. The bottom plate on the main rail continued to deform and delaminate when the JMIP was loaded/unloaded onto/from the Palletized Load System (PLS) truck.

C. <u>OBSERVATION</u>. The bottom plate on the main rail continues to deform and delaminate when the JMIP is loaded/unloaded onto/from the PLS truck.

Photo 12. Deformation of Main Rail

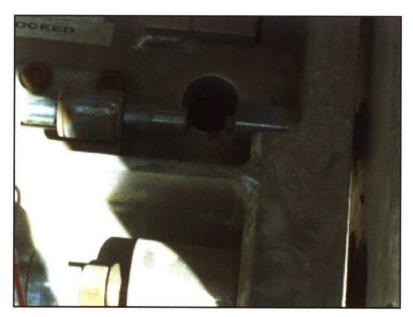
The pins that hold the A-frame in the container transport position and that failed during testing were reported to have been manufactured incorrectly. The pins were replaced for follow-on testing (06-04G, 06-04H, 06-04J) and successfully completed testing.

- 3. The pins that hold the A-frame in the container transport position both failed and sheared.
- 4. The screws and springs on many to the tie-down rings were damaged which prevented the keepers from properly engaging.

Photo 13. Damaged Container Transport Pin

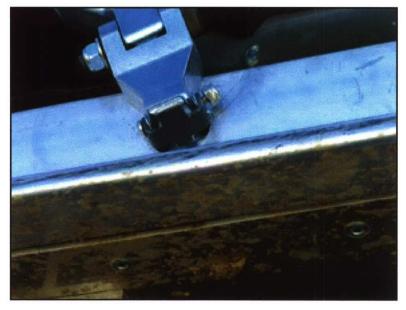
Photo 14. Keeper Not Properly Engaged

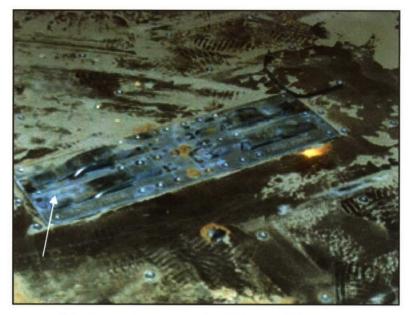
- 7. The spring steel around the JMIC to JMIP locks was damaged and deformed. Additionally, one (1) set of JMIC rings would not properly operate until the dirt was removed.

Photo 16. Damaged JMIC Lock Covers

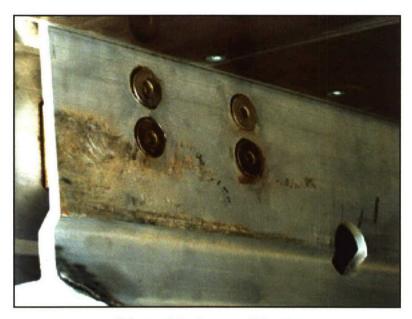
- The hex head rivets on the top of the deck and along the main rail at the
 A-frame end were loose.
- 11. The JMIP rails were bowing in following extraction of the JMIP from the intermodal container onto the PLS truck.

Photo 18. Loose Rivets
